Re: San Jacinto River Waste Pits Superfund Site

# IMPACT OF DREDGING ON THE SAN JACINTO RIVER WASTE PITS TIME CRITICAL REMOVAL ACTION SITE

**December 2011**

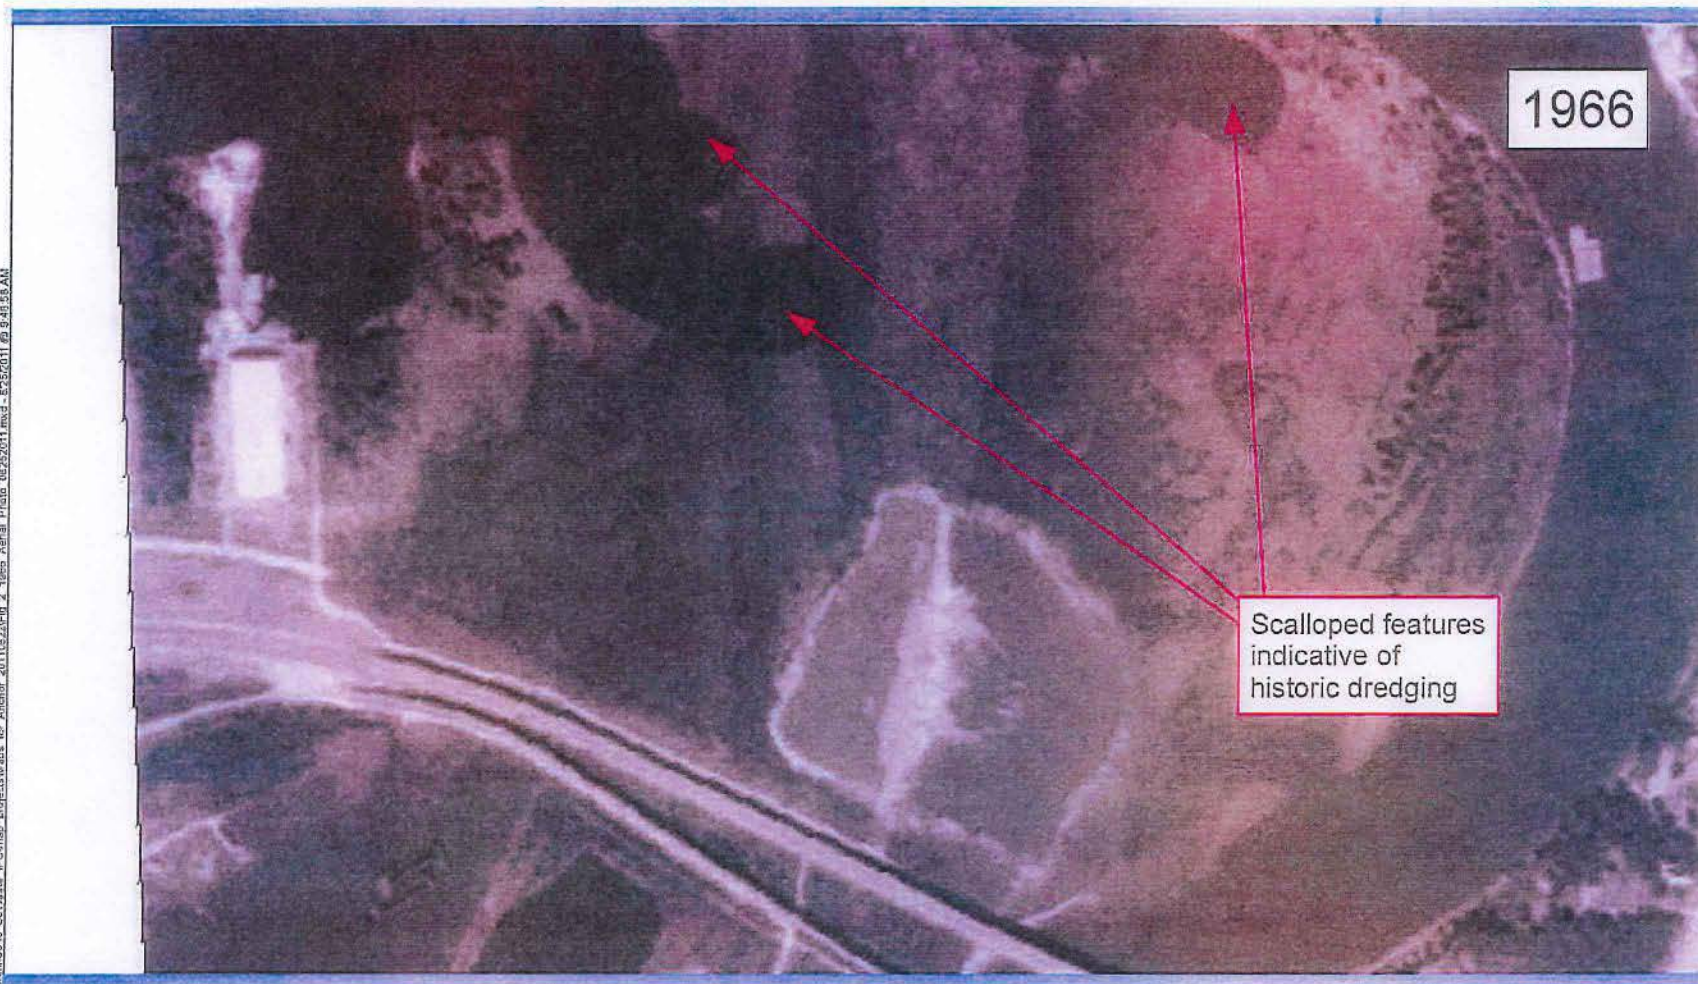
**Figure 2**  
1966 Aerial Photo  
Impact of Dredging on the San Jacinto Waste Pits TCRA Site  
SJRWSP Superfund/MIMC and IPC

- On Figure 2 (1966 conditions), the integrity of the berms surrounding the Impoundments is clearly shown. Figure 2 also depicts evidence of early dredging in the area north and west of the TCRA Site, shown by the linear cuts into the marsh with leading arcs at the limits of dredging into the shoreline. The arcs are indicative of a dredge "swing" as it advances into the shoreline to mine materials, and similar features can be observed in more recent aerial photographs of the area. Typical sand dredging operations are described in the attached Appendix B.

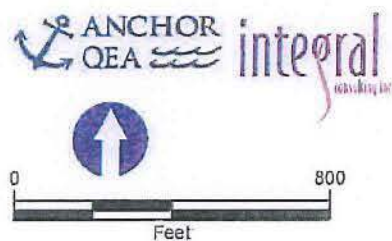
**Figure 4**  
1998 Aerial Photo  
Impact of Dredging on the San Jacinto Waste Pits TCRA Site  
SJRWP Superfund/MIMC and IPC

- Figure 4, an aerial photograph taken in 1998, shows a breach in the edge of the northwestern berm of the TCRA Site, apparently caused by undermining in this area by dredging. This photograph also shows significant changes on the Big Star property and the shoreline of the eastern side of the Big Star property. Note the alluvial fan-like deposit along the eastern shoreline of the Big Star property, in what appears to be a newly formed mass of intertidal sediment. In addition, a plume of turbid water is emanating from the new sediment mass.

The aerial photographs show that by the time the 1998 aerial photograph (Anchor Report, Figure 4) was taken, a portion of the levee along the northwest portion of the Site waste impoundments had been knocked down. As discussed in the Anchor Report, bathymetric surveys of the northwest corner of the Site waste impoundments show that dredge line cuts through this area of the impoundments. Thus, it is clear that the dredging activities conducted by the Dredging Parties in the late 1990's pursuant to HIT Permit No. 19284 resulted in the undercutting and collapse of portions of the perimeter levee in this area of the impoundments.
